Repair of Structural Defects on Concrete Pier at Luzon Port

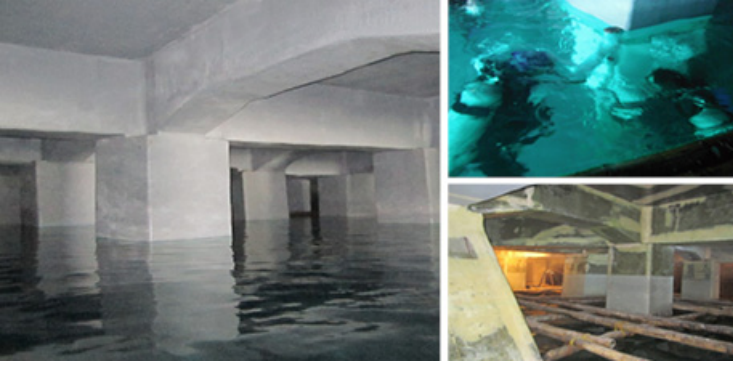
Luzon Port in the Philippines caters mainly to shipping vessels transporting general and Roll-on Roll-off (RORO) cargo and passengers to other provinces. It forms part of the Central RORO Spine that provides a critical transport link to the many islands of the Philippines. This reinforced concrete pier structure was in a severely deteriorated state due to years of use with no regular maintenance or repair. The use of fiber reinforced polymers (FRP) was proposed by the port consultant for the proposed structural upgrade.

The Tyfo[®] SEH System using the Tyfo[®] SW-1 and SW-1S underwater curing epoxies were used to restore and strengthen the structure. The severely corroded steel rebars were replaced and the surface the concrete members were restored to their original profile using specially formulated epoxy mortar. The structural members such as piles, beams and deck slab were wrapped with the designed layers of the Tyfo[®] SEH System for strengthening and corrosion protection.
