Strengthening of Deflected Beams at HSBC bank

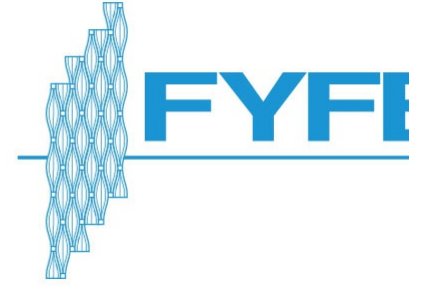
This bank building in Johor Bahru, Malaysia is a 3 storey shop lot building. The tremors or vibrations felt by the occupants at the second floor office space was a concern to the building owners and occupants. Fibrwrap Construction (M) Sdn Bhd was engaged to carry out investigation and recommendation for the remedial works. Upon successfully determining the apparent defects in the structural framework, a proposal and remedial works were carried out to completion with minimal or no disruption to the activities of the bank.

The areas affected were the general banking hall, VIP premier centers and office areas of the building.

- Excavation to construct pad footing at the ground floor.
- Erection of steel columns from the ground floor to the second floor.
- Installation of Tyfo® Fibrwrap® System to beams
- Structural crack injection
- Repair to waterproofing defects
- Vibration monitoring instrumentation to the structure
- Protection, removal and reinstatement of all Interior finishes, electrical services and ventilation systems affected by the works.
