Steel Factory Building in Singapore

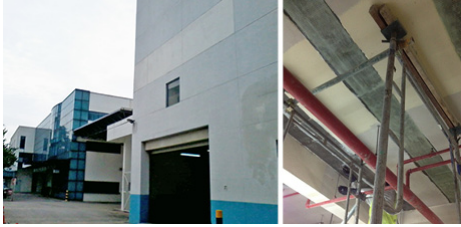
Located at Gul Circle road of Singapore, Asian Steel is a steel production factory that comprised of one office block and two production blocks. Equipped with a huge number of machinery, the production block is subjected to constant vibration caused by the production operations. Together with the periodical full load acting on the slab, several severe cracks were found propagated. Thorough structural investigation was carried out to confirm the depth of the cracks. The structure was propped before the strengthening work being carried out.

Epoxy grouting and Tyfo® Fibrwrap® Systems were proposed to repair the cracks and strengthen the structure. Wrapping the slab along the main spanning direction has significantly enhanced its existing capacity. The major challenge to this project was that all the existing services were not allowed to be dismantled or even diverted. As such, the wrapping design was re-proposed to suit the site conditions. Another challenge to this project was that the building remained operational during the repair and strengthening works.
