Strengthening of Deflected Beams at HSBC bank

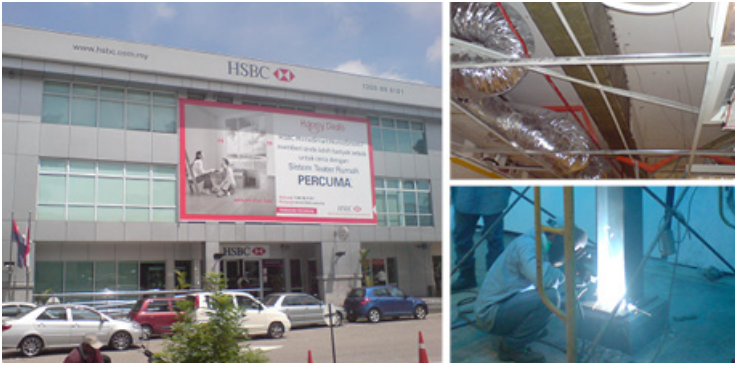
This bank building in Johor Bahru, Malaysia is a 3 storey shop lot building. The tremors or vibrations felt by the occupants at the second floor office space was a concern to the building owners and occupants. Fibrwrap Construction (M) Sdn Bhd was engaged to carry out investigation and recommendation for the remedial works. Upon successfully determining the apparent defects in the structural framework, a proposal and remedial works were carried out to completion with minimal or no disruption to the activities of the bank.

- Excavation to construct pad footing at the ground floor.
- Erection of steel columns from the ground floor to the second floor.
- Installation of Tyfo® Fibrwrap® System to beams
- Structural crack injection
- Repair to waterproofing defects
- Vibration monitoring instrumentation to the structure
- Protection, removal and reinstatement of all Interior finishes, electrical services and ventilation systems affected by the works.
