### Repair of Structural Defects on Concrete Pier at Luzon Port

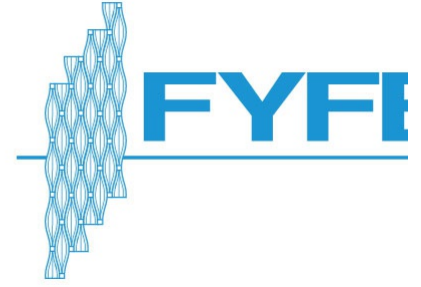
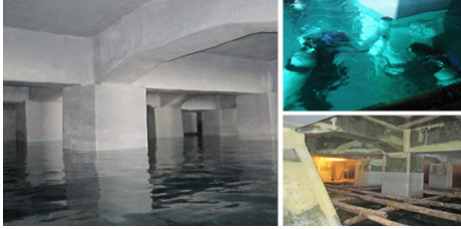
Luzon Port in the Philippines caters mainly to shipping vessels transporting general and Roll-on Roll-off (RORO) cargo and passengers to other provinces. It forms part of the Central RORO Spine that provides a critical transport link to the many islands of the Philippines. This reinforced concrete pier structure was in a severely deteriorated state due to years of use with no regular maintenance or repair. The use of fiber reinforced polymers (FRP) was proposed by the port consultant for the proposed structural upgrade.

The Tyfo® SEH System using the Tyfo® SW-1 and SW-1S underwater curing epoxies were used to restore and strengthen the structure. The severely corroded steel rebars were replaced and the surface the concrete members were restored to their original profile using specially formulated epoxy mortar. The structural members such as piles, beams and deck slab were wrapped with the designed layers of the Tyfo® SEH System for strengthening and corrosion protection.
