### Lion Rock Tunnel Water Main Rehabilitation

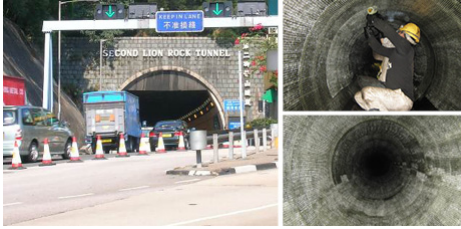
Rehabilitation of this pressurised water main was a very challenging project. Rehabilitation was required for five 1200mm diameter to 1500mm diameter water mains inside the Lion Rock Tunnel, totaling 7.5km. The busy traffic conditions made it impossible to implement any prolonged road closures in the tunnel area, rendering all conventional pipe rehabilitation techniques unfeasible.

Being light and easy to handle and without the need of road closure, the Tyfo® Fibrwrap® system was selected as an internal structural lining to these water mains.

- Survey for existing pipe conditions.
- Pipe rehabilitation design.
- Internal surface preparation to existing pipes.
- Internal installation of the TYFO® Fibrwrap® Composite System.
